Photo Report by DMNC Roofing

Nov 3, 2020 | 9 Photos

Inspection Report

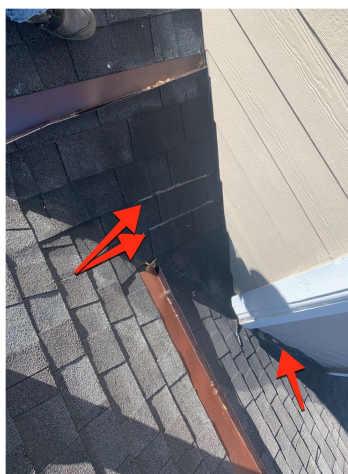
Shingles have been sealed on areas they should not have been sealed. This could be an indicator for prior leakage.

These corners are in general hard to manage and the water diverters are a good way to litigate potential issues.

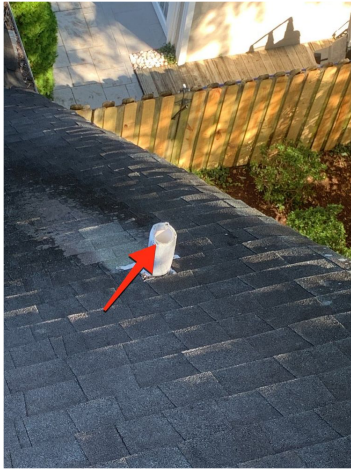
Lead Pipe Jack was chewed on by rodents this should be fixed to prevent water from entering and run down on the outside of the pipe.

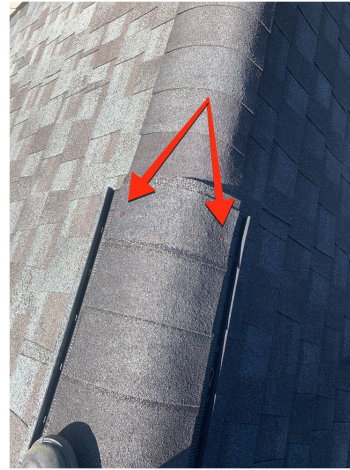
There are exposed nails throughout the roofs ridge cap line. While these nails are necessary to hold the last ridge cap in place, they should be caulked to prevent water from running in.

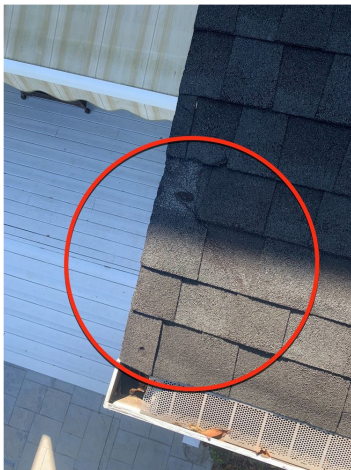
This is right of the back deck on the flat part of the roof.

This is the only area where minor wind damage has been found. While this damage is not causing any leaks at this point, it will be vulnerable to future wind gusts. The creased shingles should at least be sealed. so they can't easily flip up.

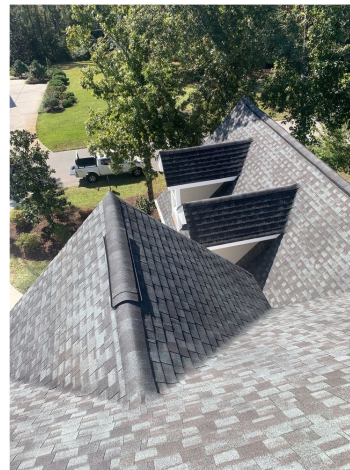
No storm damage found on front slope.

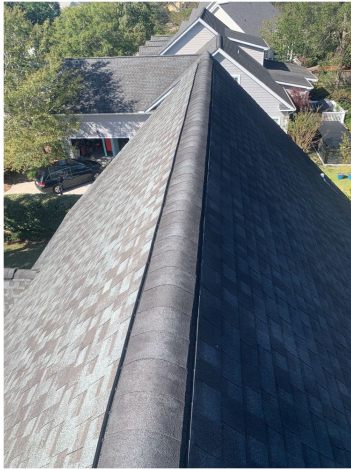
Ridge vent installed correctly.

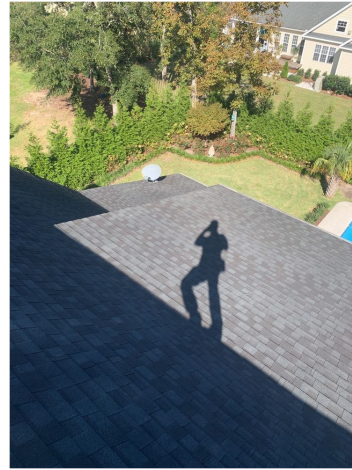
No storm damage found on rare slope.

We suggest to re-install the satellite dish to the wall or fascia as roof mounted satellites can cause water entrance and slowly deteriorate the plywood.

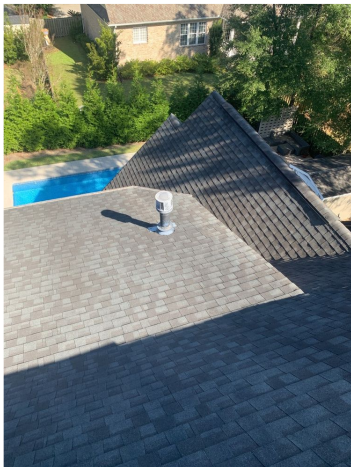
No Storm damage found.
