RODRELO LLC.
Consulting and Representation

Failure Analysis Report

Report Number: 1-RR-618

- Well: 1-1-1
- Operator: Operador 1
- Date of failure: 11/2/2020
- Artificial Lift type: SUCKER ROD PUMPING
- Type of failure: SUCKER ROD PART
- Failure description: ¾" Norris 97 Guided 4x
- Depth of failure: 4400'

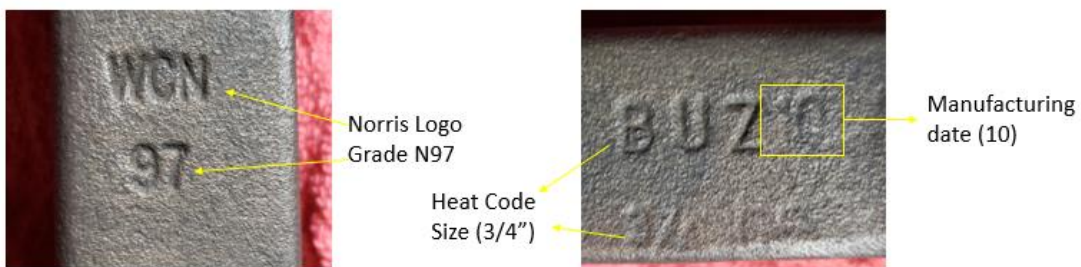
Figure 3: Wrench Flat information

- Sucker Rod Size: $\frac{3}{4}$ "
- Manufacturer: Norris
- Grade: N97 (4330M High Strength type of sucker rod)
- Sold by: N/A
- Condition: REFURBISHED
- Wrench flat information:
 - Manufacturing Date: 2010 (Norris Sucker Rod) – 10/2018 (WFT Coupling)
 - Heat Code: BUZ (Norris Sucker Rod)

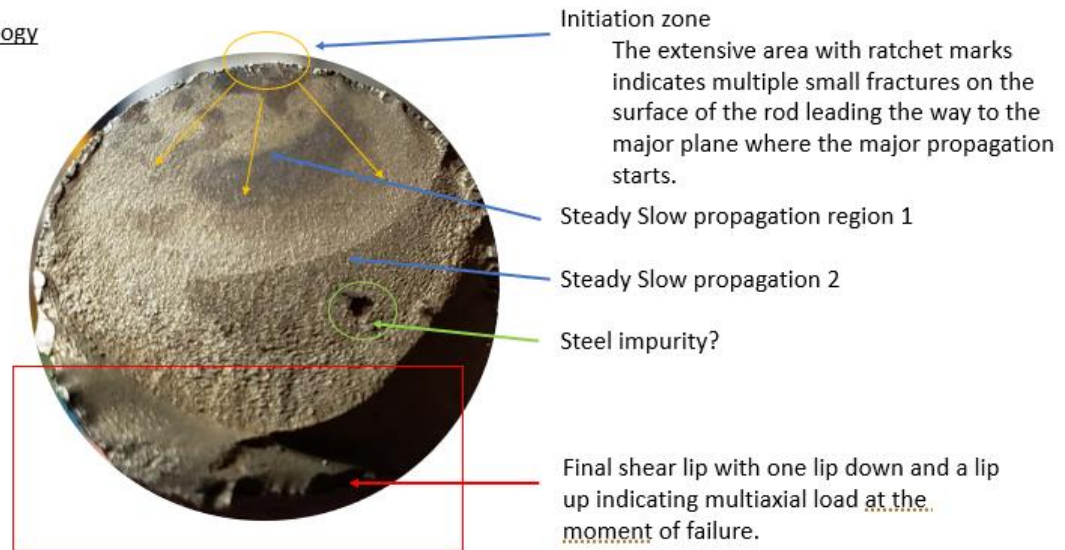
Figure 4: Failure Morphology Evaluation

- Multiaxial loads are observed on the final ductile section ("one lip up, one lip down" Characteristic bending morphology)
- A large slow propagation area was found (around 80%), this indicates low loading stress on the rod string section under analysis. The sample also shows two distinct slow propagation process indicating loading regime.

The sample shows a large steady fatigue propagation area where friction was the predominant deformation method until the cross sectional area was small enough to complete the short cycle and ductile final break.

The large slow propagation area (more than 65% of the cross section) indicates low loading for this rod within the string.

The initiation area denotes a significant amount of stress risers and propagation planes until one predominant plane lead the plastic deformation that take place at the crack tip while propagating.

The final break lip also shows signs of multiaxial stress (normally bending or flexion) at the time of failure. This is characteristic of string sections with severe dog leg or compression especially close to the sinker bar or pump section. The proximity to the upset bed area indicates probable bending stress product of compression.

- Strongly recommend the use a **tougher grade like KD (4320M) or KDP rods instead of high strength**. High strength rods like N97s have a significantly lower toughness and by it, more susceptible to reach critical size of stress risers quicker, resulting in premature failures.

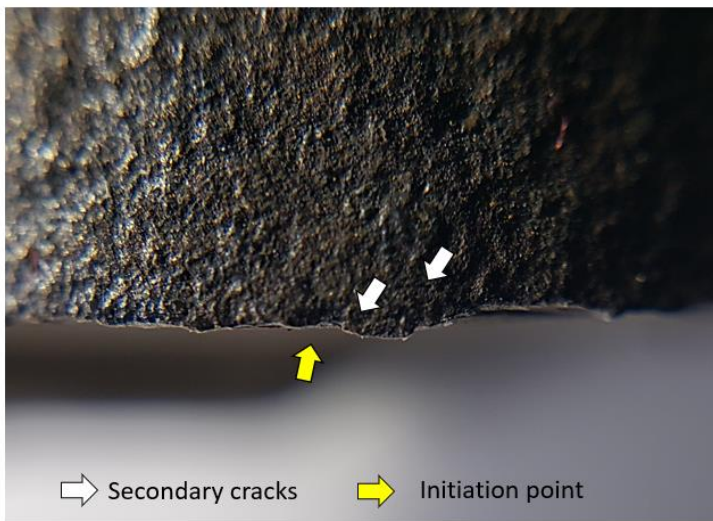
Figure 5: As received Condition

- The failure mechanism corresponds to a corrosion-fatigue process with an initiation section located on the periphery of the rod body on one of the multiple localized corrosion cracks examined.

The initiation point of the failure front shows secondary cracks. The crack pattern is irregular probably with initial assistance of sulfide stress cracking (SSC) or microcracking generating multiple ratchet marks.

Most high strength steels are susceptible exposed to SSC or other kind of embrittlement due to its energized microstructure and Nickel content. Nickel makes the lattice wider, allowing for atomic Hydrogen to allocate in between of their interstitial lattice space.

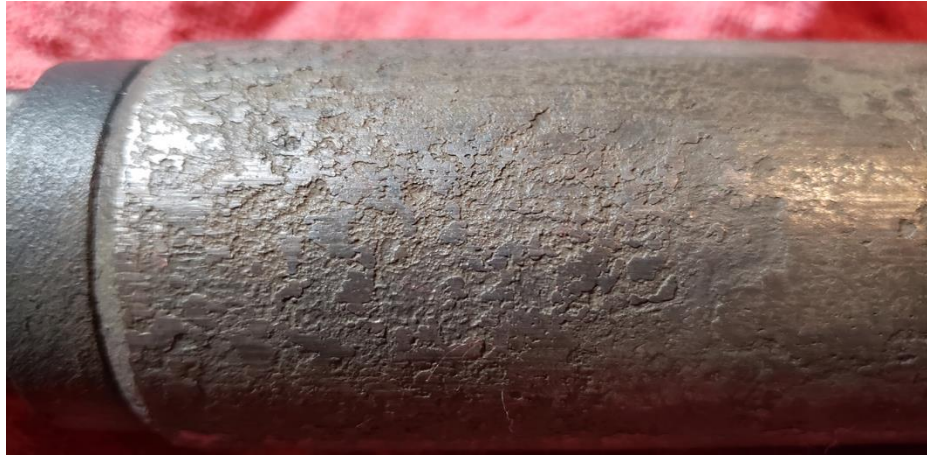
Figure 6: delaminated SM coupling

- The spray metal coupling attached to the rod sample showed a heavy corrosion-erosion attack. It seems that the contact with the tubing due to buckling, the solids in solution and the flow around the couplings could delaminated the SM layer. Once delaminated the corrosion took place on the base material.

The spray metal coupling showed a heavy corrosion-erosion attack. It seems that the contact with the tubing due to buckling, the solids in solution and the flow around the couplings could delaminated the SM layer. Once delaminated the corrosion took place on the base material.

- Strongly recommend to re evaluate the need of a full guided string. The addition of friction (guide material has a higher friction coefficient than bare steel) could be potential be increasing the buckling tendency on the section from 4000-5000ft. Evaluate the use of **low friction couplings** instead of guiding for wear on tubing solutions.

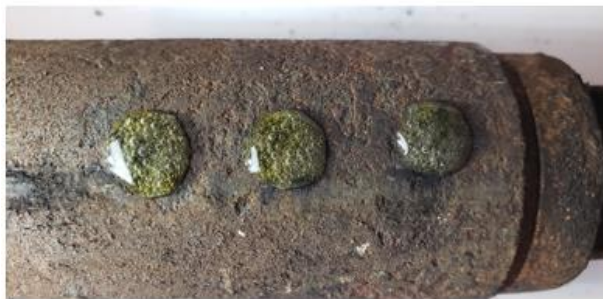
Figure 7: ISDT for CaCO_3 and FeS

- The results from the ISDT (Iron Sulfide Detection Test) indicates a strong response of a superficial layer of CaCO₃ and a smaller film of FeS attached to the rod body. This indicates a risk of under deposit corrosion, especially on soft deposits like CaCO₃. These brittle deposits generate cracks where the production fluid could stay stagnant and accelerate localized corrosion due to a crevice process.

The evaluation with the ISDT solution of the deposits indicated the presence of CaCO_3 due to the effervescence (CO_2 release) from the reaction with the HCl . The Yellow coloration and the mild rotten egg smell indicate the subjacent presence of FeS attached to the rod body. This combination normally is a result of under deposit localized corrosion.

Typical reaction for FeS (yellow coloration) mixed with a mild amount of carbonates (base full of small bubbles).

- **Review the chemical treatment** in place addressing dosage and type of chemical utilized for a better efficiency especially avoiding CaCO_3 scale deposits.

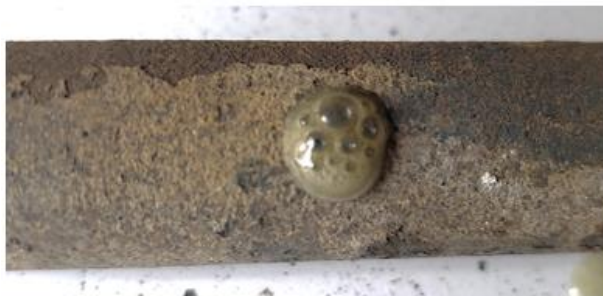
Heavy effervescence typical of CaCO_3 reaction with HCl in the solution

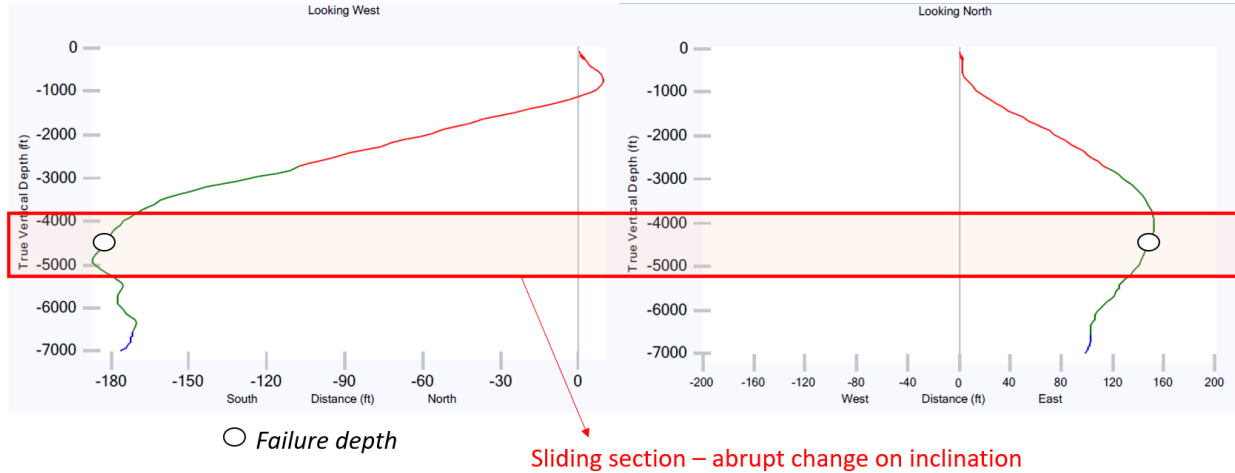
Figure 8: Inclination anomaly

- The well analysis indicates probable sliding when drilling at the section from 4200 to 4600 ft deep creating an optimal environment for micro doglegs not perceived by the MWD or standard 1 every 100ft measurements of normal surveying techniques. The change in trajectory may be the contributing factor to the exaggerated friction on that section which could induce more buckling than simulated by RODSTAR.

- *Sliding area: inclination anomaly*
 Normally slight changes of inclination or orientation are seen in survey with measurement intervals of 1 every 100ft, but operators still see operational issues on these wells with no further explanation from a simulation point of view.
 When drilling deviates from the expected 2 degrees dog leg they try to re orientate the drill bit by adding weight. This sudden weight addition often generates sliding creating localized areas for abrupt changes in DLS not noticeable from standard measurement intervals. The only way to proper assess these issues is with a more define measurement with intervals o around 25 to 30 feet.

The well geometry depicted on the string design simulation indicates that a change of inclination in the area of failure, and in combination with the excess of guides, a “hanging” area that multiplies the risk of bending due to compression of the string above the inclination anomaly.

- Evaluate previous history of wear on the section from 4000ft to 5000ft. if so, I would recommend running a micro surveying log (gyro) with shorter intervals, around 25 to 30 ft instead of 100ft.
