Attic Ventilation and Moisture Research Study

FINAL REPORT | JUNE 2014

Homeowner
Protection Office
Branch of BC Housing

MORRISON HERSHFIELD

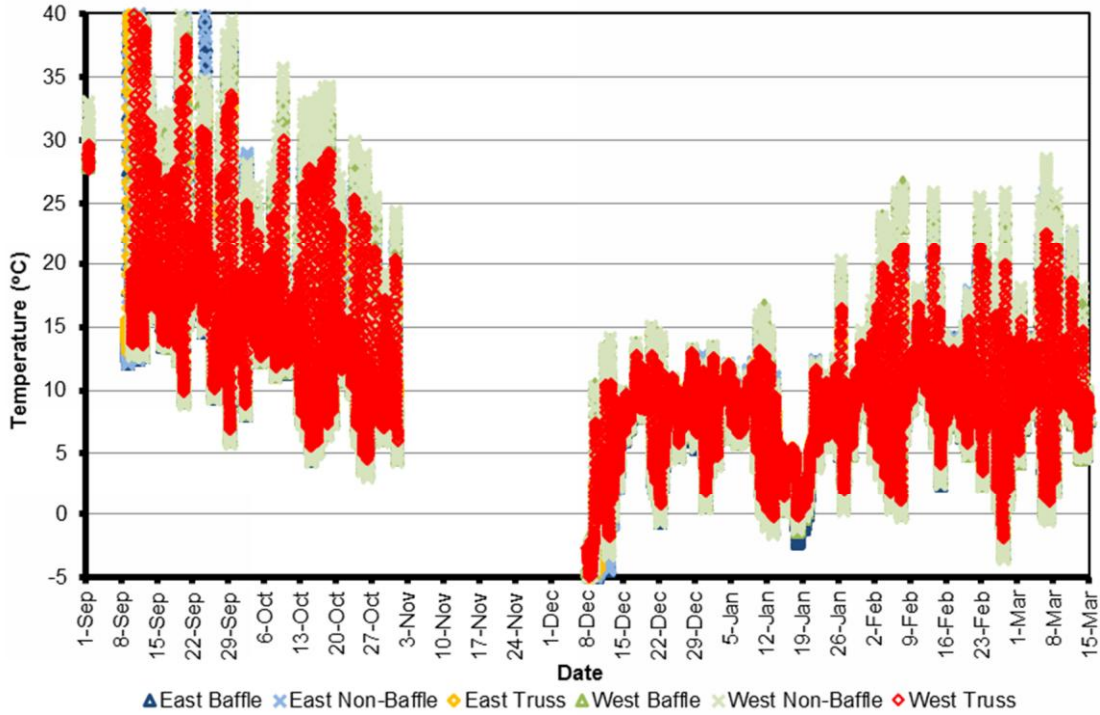
Figure B.15: Unit 2 long wood term temperatures

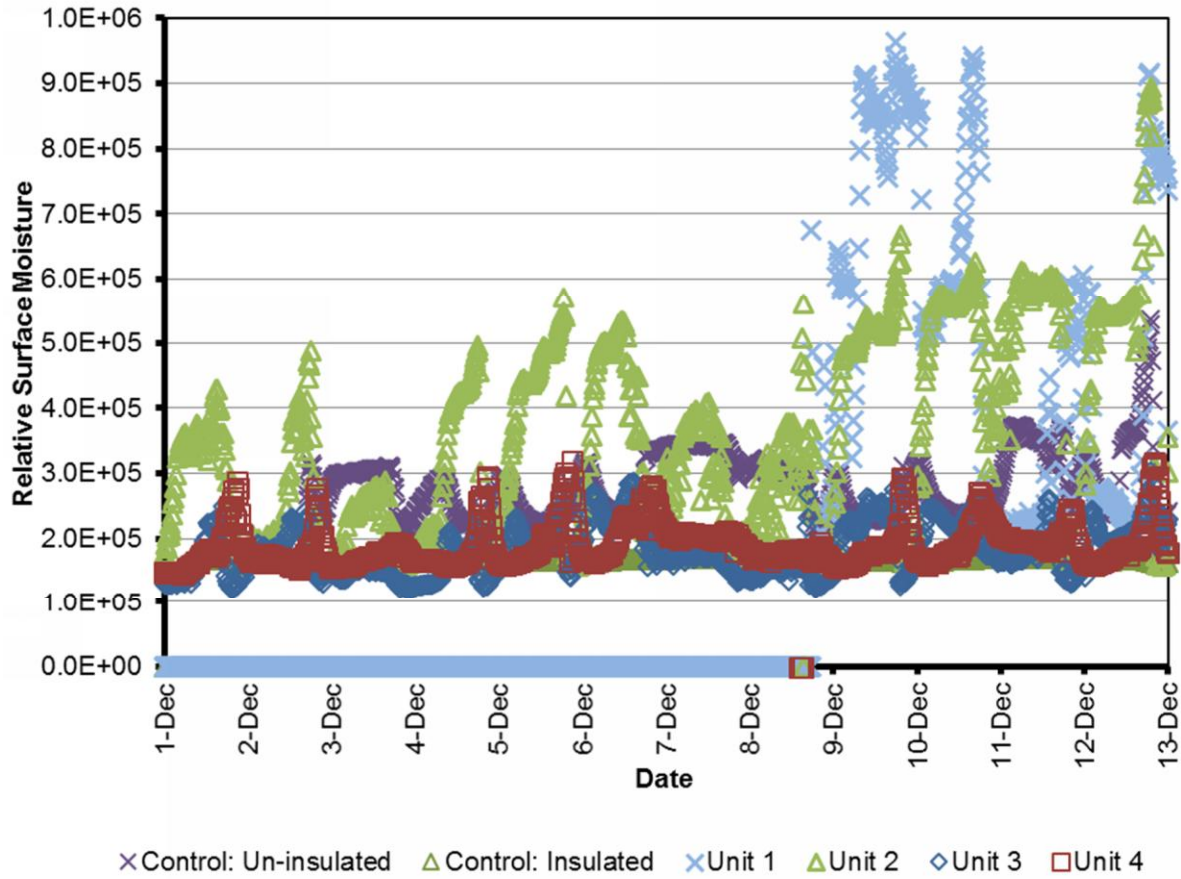
Figure B.37: Condensation Formation

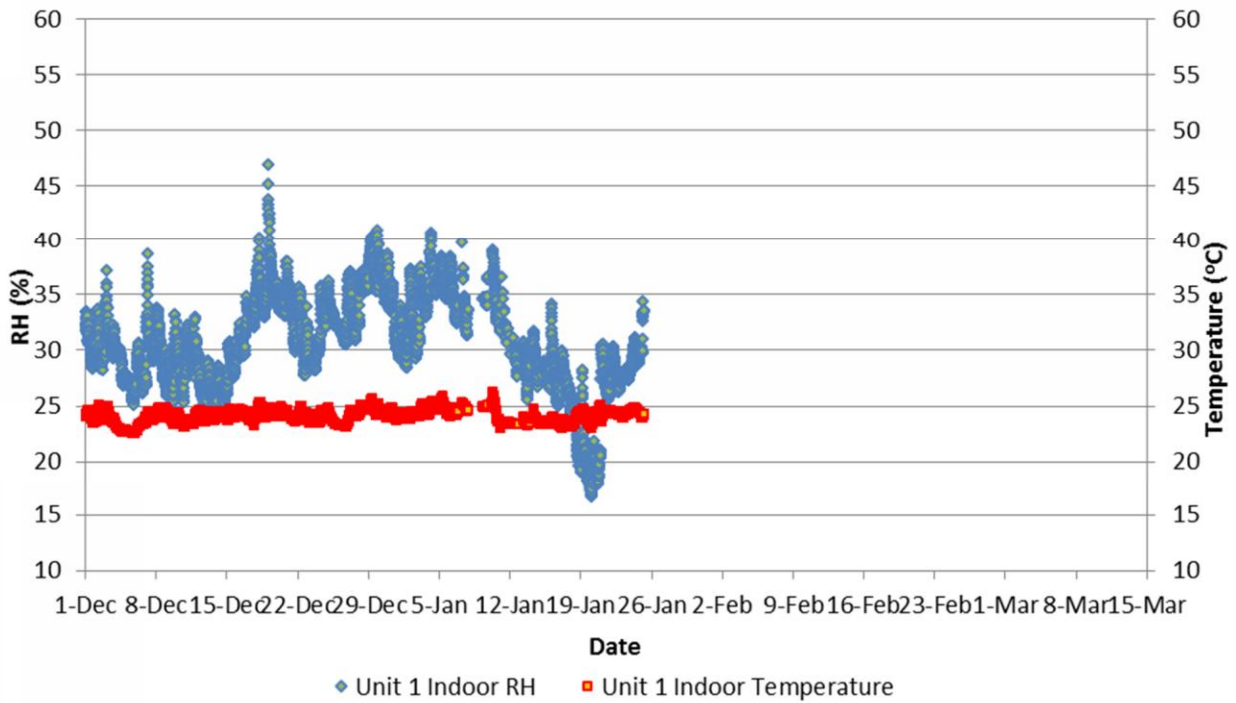
Figure B.38: Unit 1 Indoor Temperature and Relative Humidity

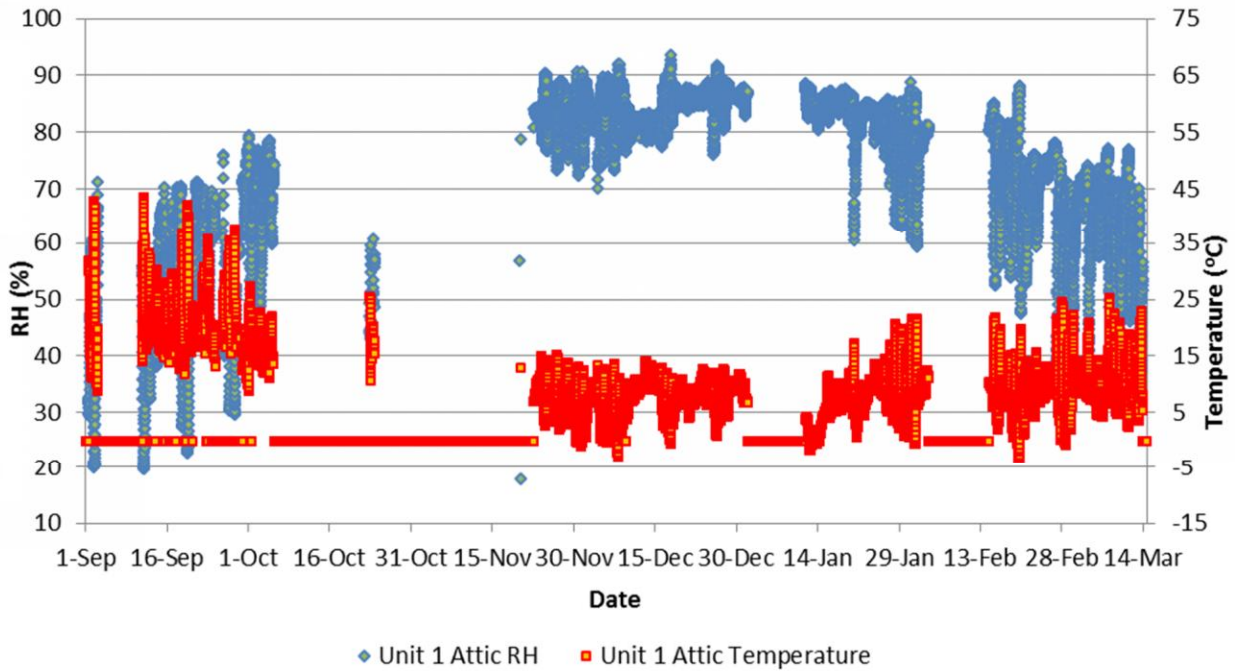
Figure B.39: Unit 1 Attic Temperature and Relative Humidity

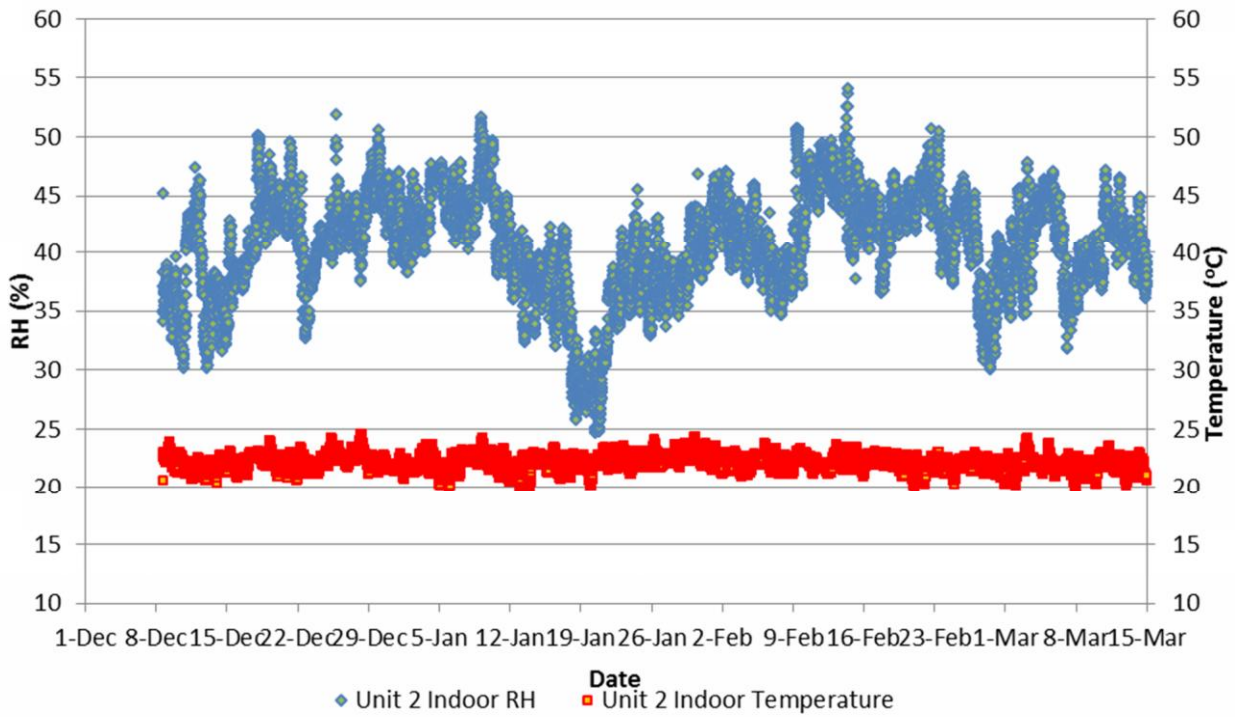
Figure B.40: Unit 2 Indoor Temperature and Relative Humidity

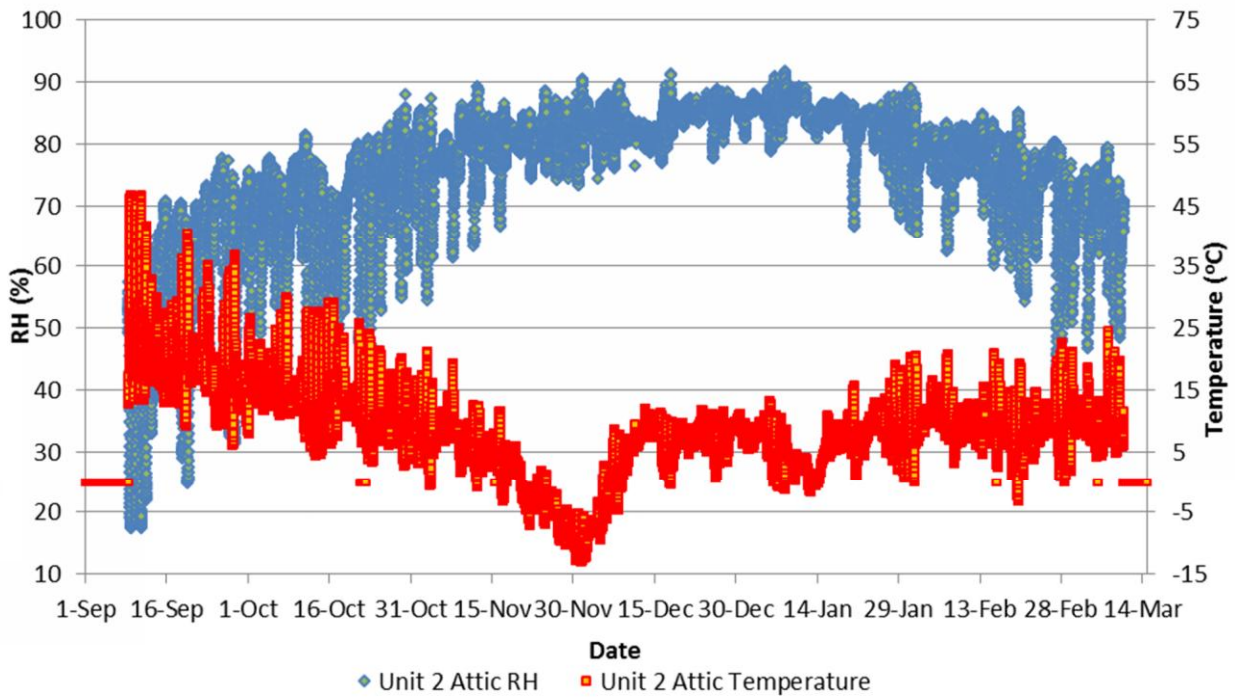
Figure B.41: Unit 2 Attic Temperature and Relative Humidity

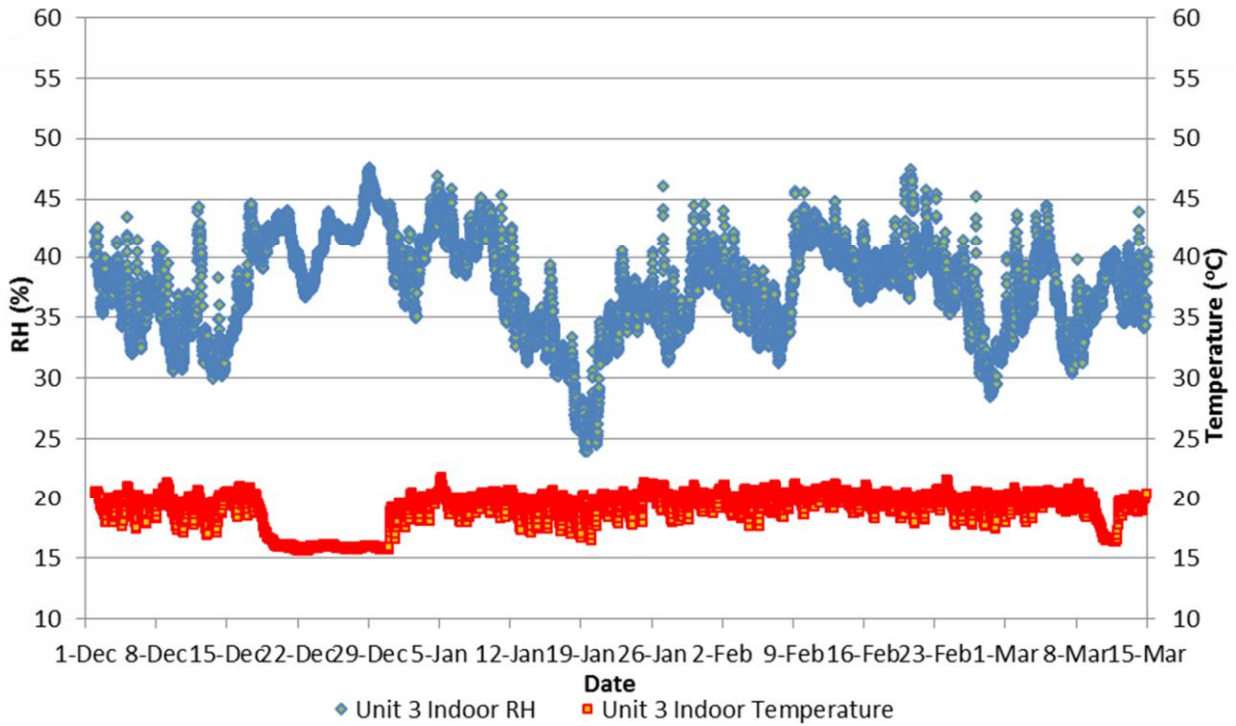
Figure B.42: Unit 3 Indoor Temperature and Relative Humidity

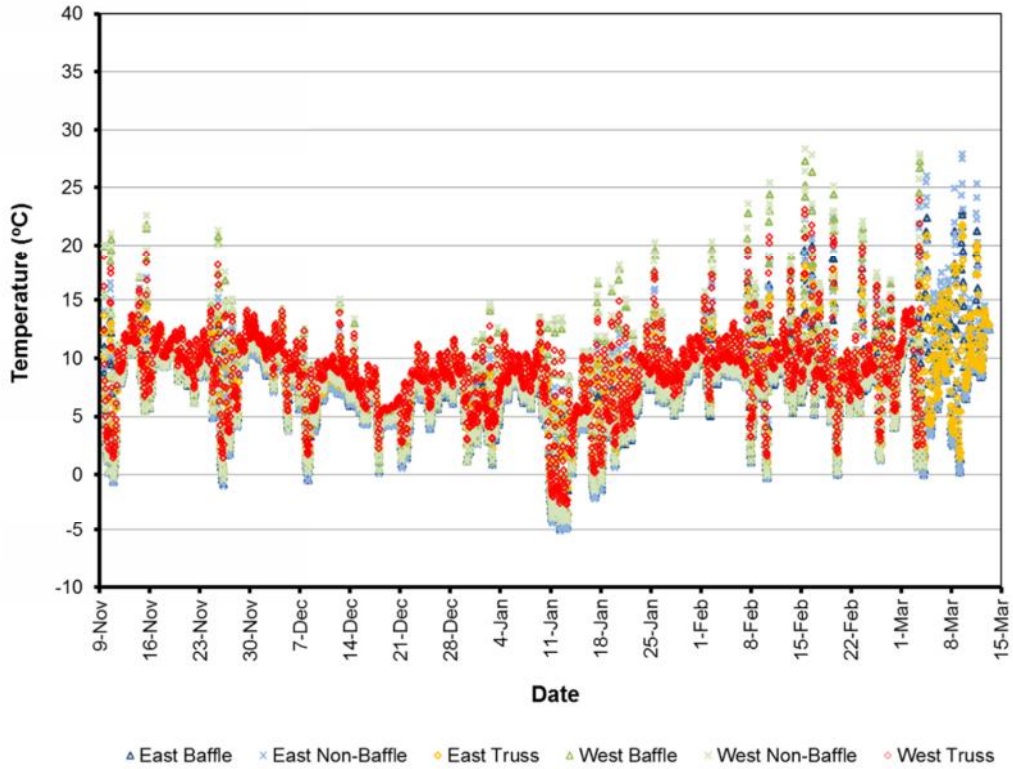
Figure A.5: Unit 1 Wood Temperatures for 2012 - 2013

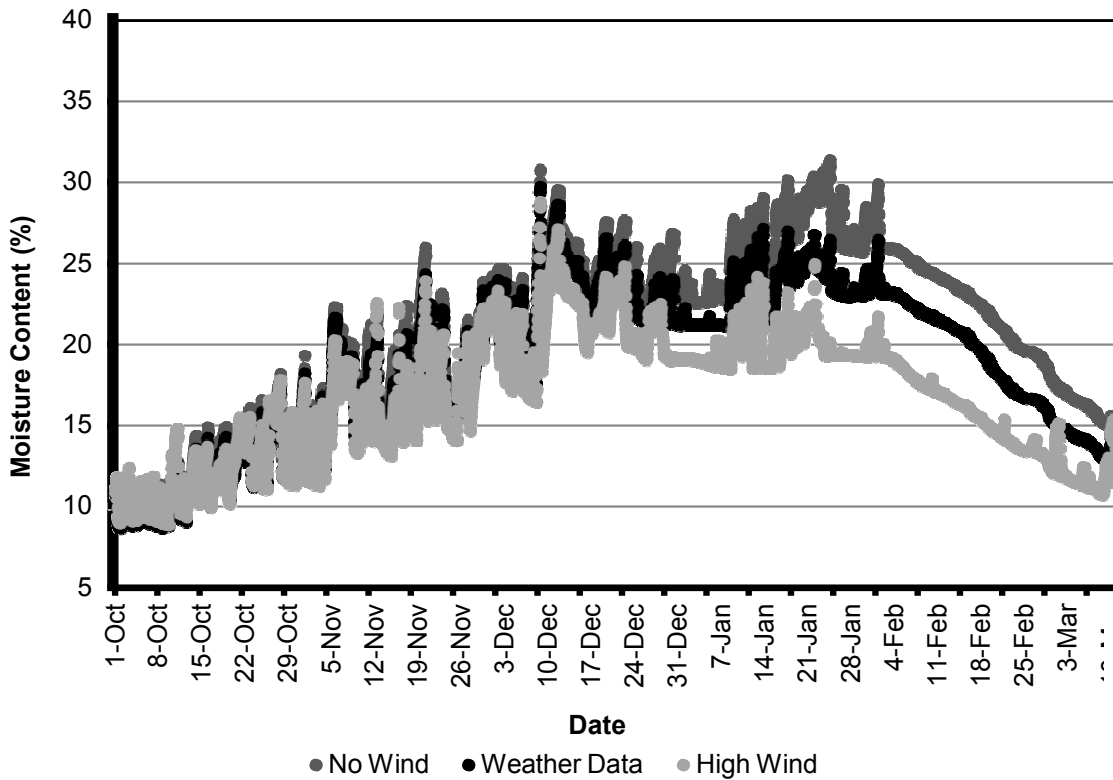
Figure B.26: West Roof Sheathing Moisture Content for Different Wind Speeds (Case ID 14, 2, 15)

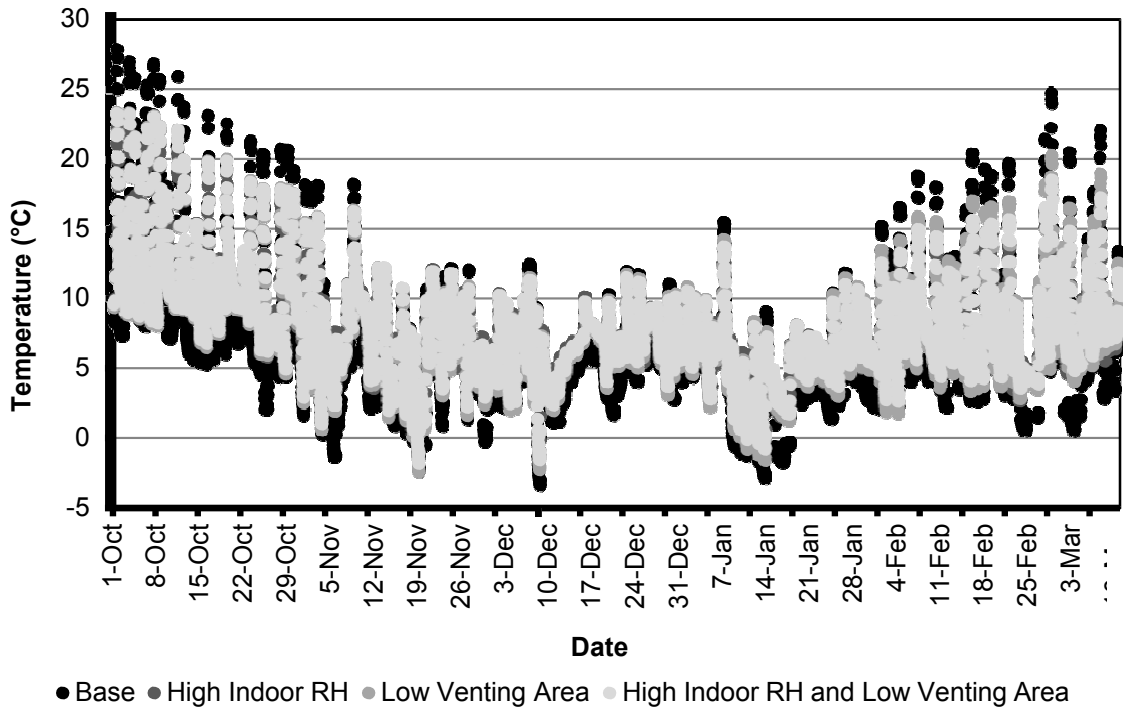
Figure B.33: East Roof Sheathing Surface Temperature with R-2.5 Sheathing Resistance and Permutations of Indoor Humidity, Interface Leakage Area, and Venting Area (Case ID 21, 22, 23)

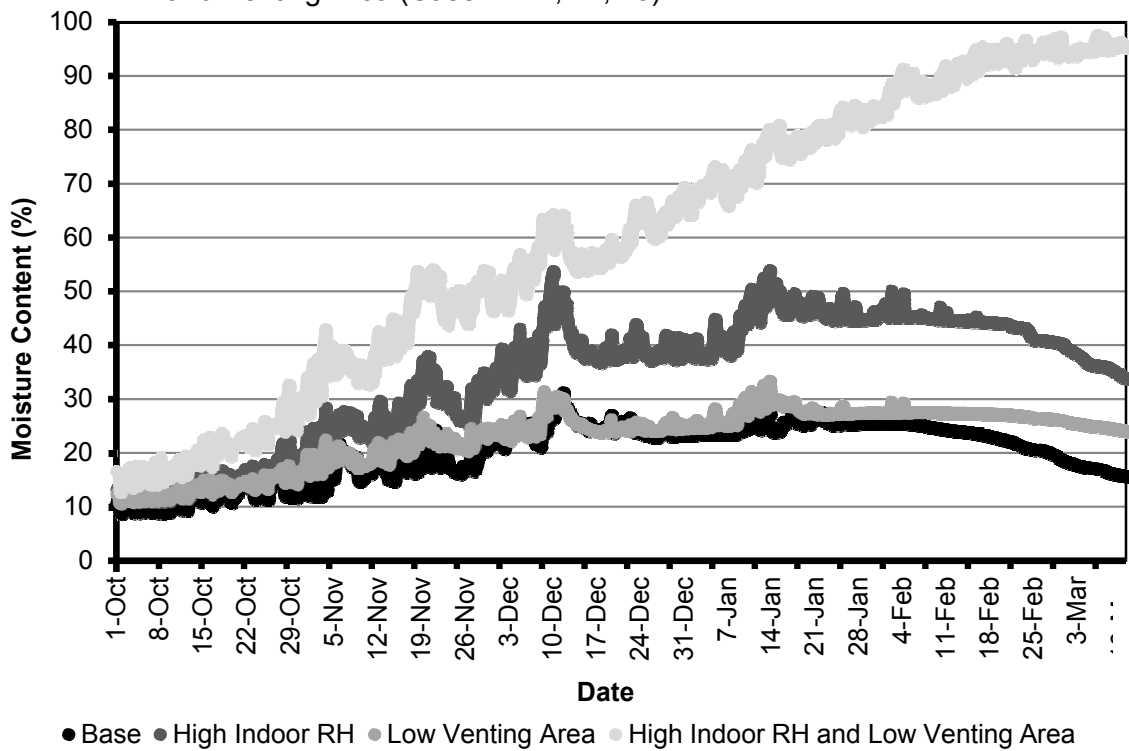
Figure B.34: East Roof Sheathing Moisture Content with R-2.5 Sheathing Resistance and Permutations of Indoor Humidity, Interface Leakage Area, and Venting Area (Case ID 21, 22, 23)

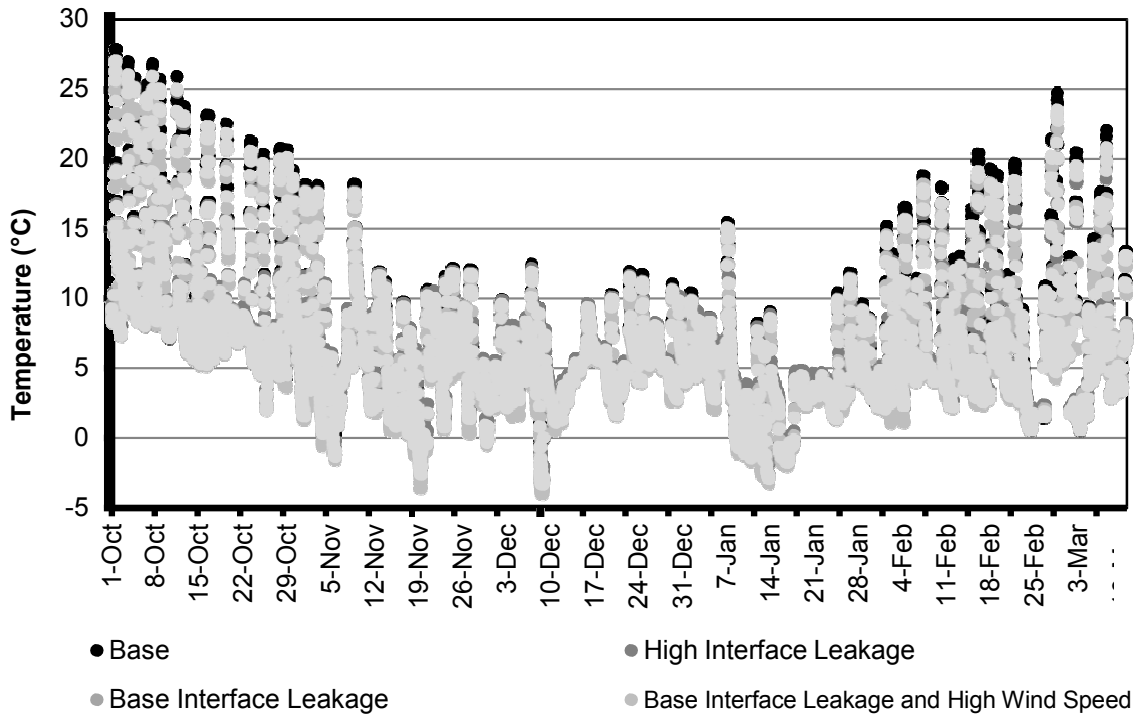
Figure B.37: East Roof Sheathing Surface Temperature with High Venting Area, High Indoor Humidity and Permutations of Interface Leakage Area and Wind Speed (Case ID 24, 25, 26)

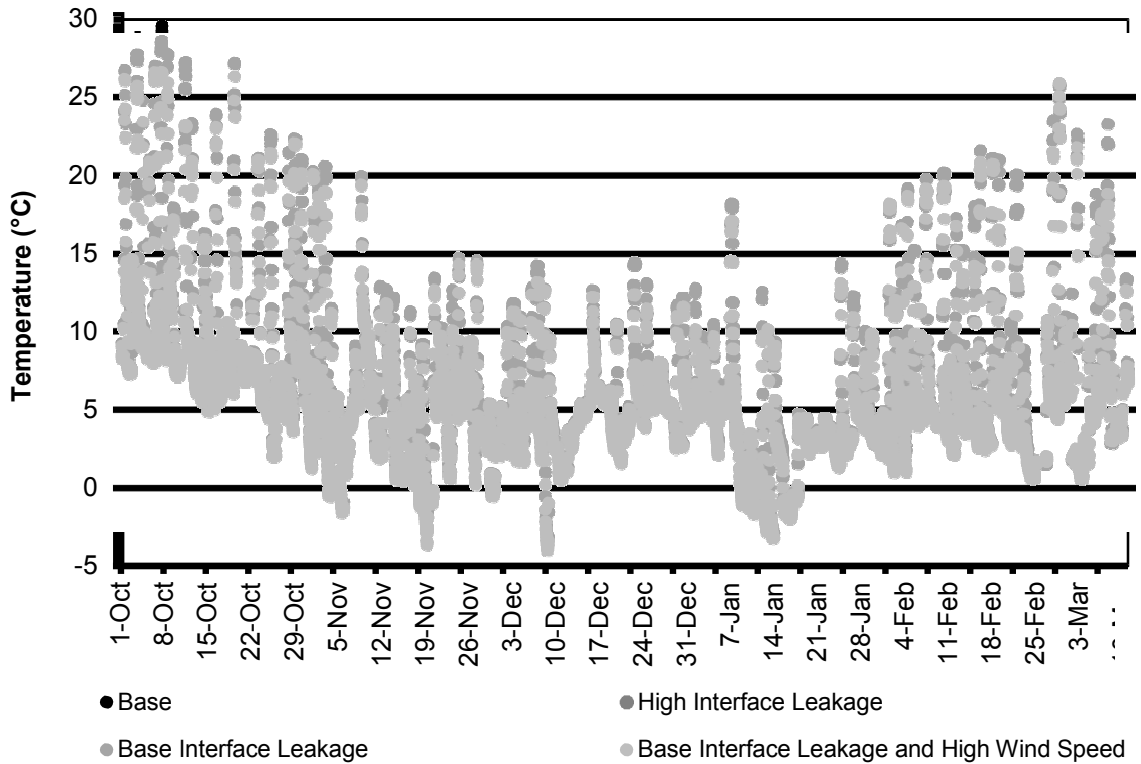
Figure B.39: West Roof Sheathing Surface Temperature with High Venting Area, High Indoor Humidity and Permutations of Interface Leakage Area and Wind Speed (Case ID 24, 25, 26)

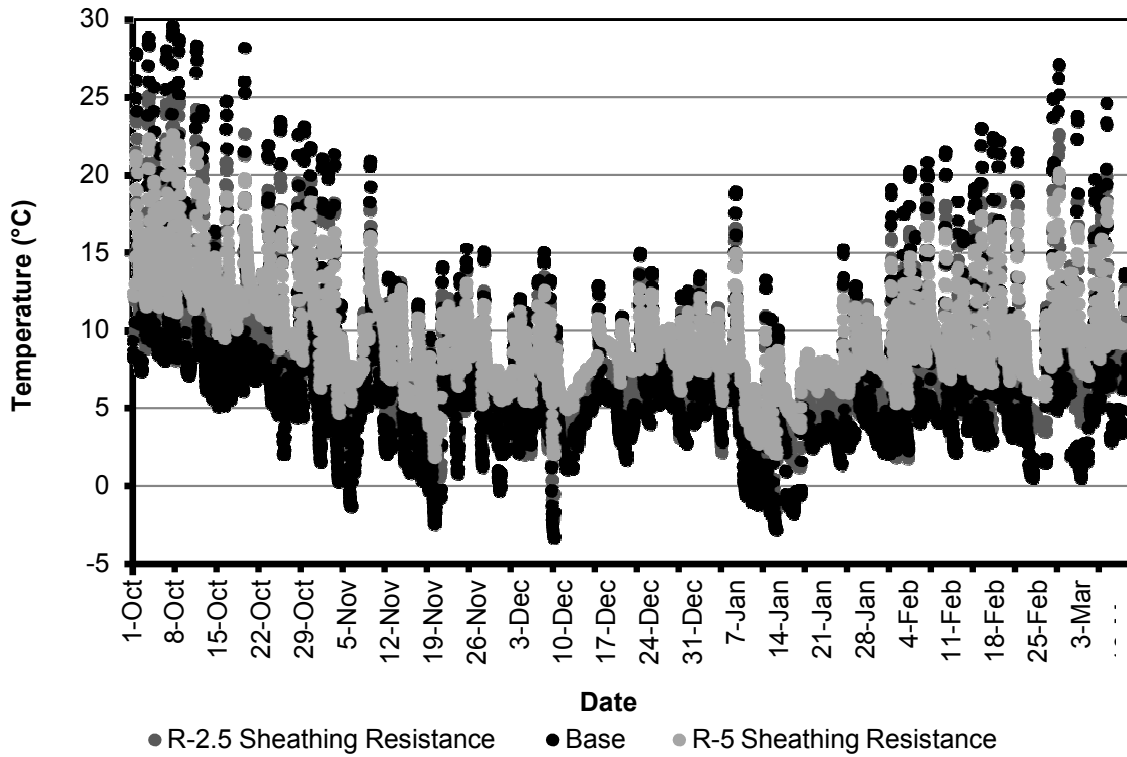
Figure B.43: West Roof Sheathing Surface Temperature with Low Venting Area and Permutations of Sheathing Thermal Resistance (Case ID 22, 2, 27)

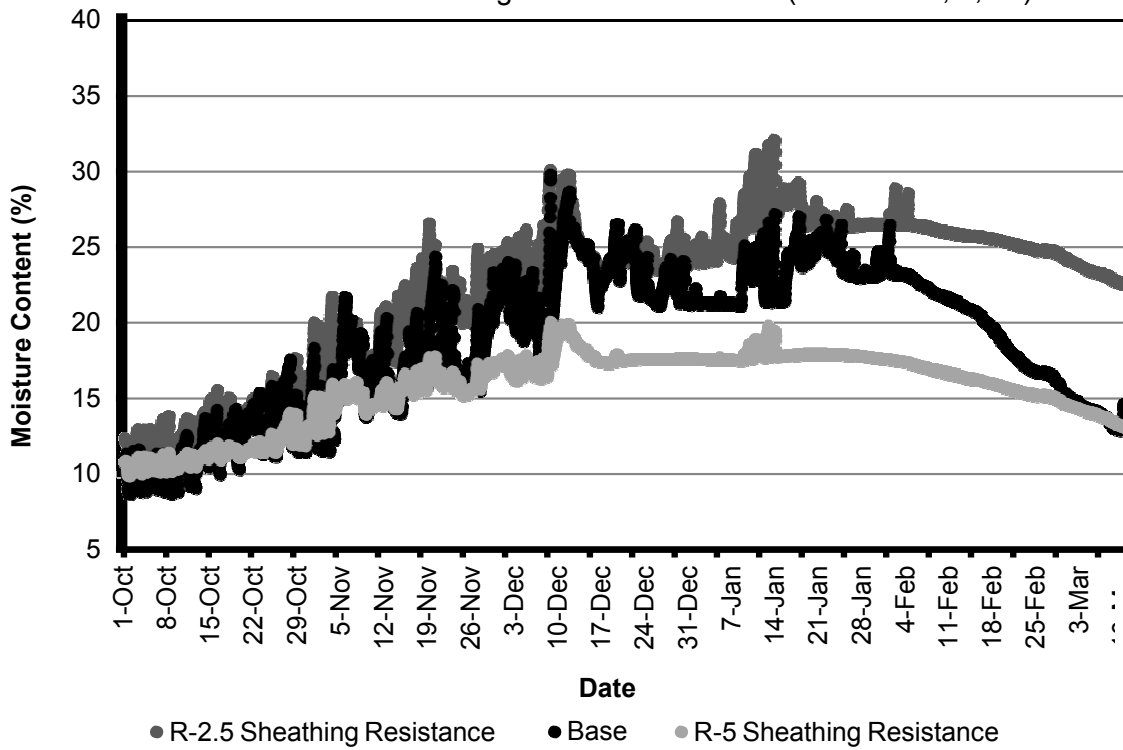
Figure B.44: West Roof Sheathing Moisture Content with Low Venting Area and Permutations of Sheathing Thermal Resistance (Case ID 22, 2, 27)
