Management of a failed implant with a self-hardening bioactive synthetic bone graft

Complex problem, modern solution

This case report highlights the use of a bioactive in situ hardening synthetic resorbable bone substitute, composed of beta tri-calcium phosphate (β -TCP) and calcium sulfate (CS), for the minimally invasive treatment of a demanding case of a failed implant in the esthetic zone. A standardized staged approach with digital implant planning and fully guided placement enabled the correct replacement of the implant, and the simultaneous regeneration of vital bone and newly-formed thick keratinised soft tissues. Patient morbidity, complication risk, cost, length and complexity of the procedures were thus minimized; resulting in a successful outcome, regarding aesthetics and function.

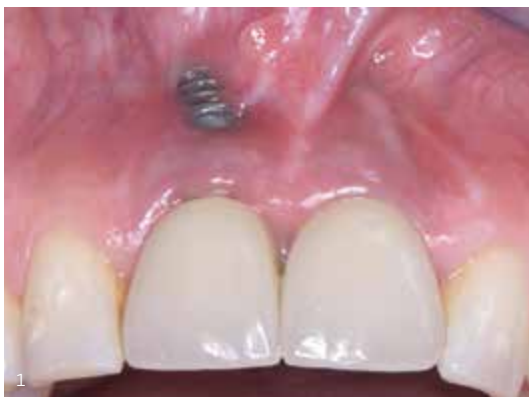
The patient, female, aged 38, presented with a wish to restore the soft tissue defect buccally to her implant 11. According to the patient, due to trauma 10 years ago, she lost both her upper central incisors, which were replaced at that time with two Xive S Plus implants (Dentsply, Mannheim, Germany) – both 5.5 mm in diameter and 9.5 mm in length – and separate implant crowns. Clinical examination revealed a soft tissue dehiscence with exposure of the labial me-

sial and apical threads of the implant 11 (Fig. 1). There was no clinical mobility of the implant nor other signs or symptoms. Regarding the adjacent implant 21 there were no clinical problems associated. The initial CBCT scan showed significant bone loss, with complete bone loss at the buccal aspect of the implant 11 (Fig. 2). The same radiological findings were also observed for implant 21. The diagnosis was that the implant 11 was not salvageable, and implant 21 had a poor prognosis. It

1 | Initial situation of the failing implant 11. Note the buccal soft and hard tissue defect, leading to the exposure of the implant threads.

was decided to treat firstly only the failed implant 11, as removal of both implants 11 and 21 at the same time would result in severe collapse of the area, that would be very difficult to restore. The treatment plan consisted of removal of implant 11, placement of a new implant 6 weeks post-op with simultaneous bone augmentation according to the Fairbairn and Leventis (2015) published protocol [1], and loading of the implant 12 weeks post-op with the final restoration.

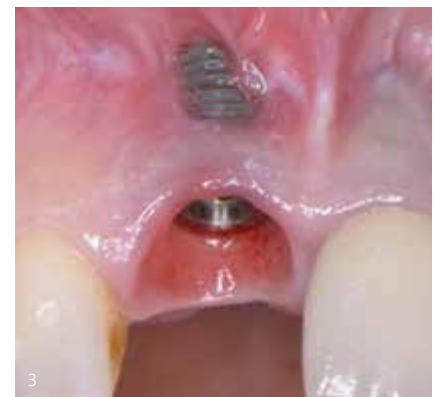
3 | Clinical view after removing the screw-retained implant crown.

Under local anesthesia, the non-salvageable implant 11 was "atraumatically" removed without raising a flap. Firstly, the screw-retained crown was removed (Fig. 3) and the implant was easily mobilised and removed using the implant driver and the ratchet in an anti-clockwise direction (Fig. 4). Then, the site was thoroughly curetted and debrided of any soft tissues with the use of Lucas hand bone curettes and degranulation burs (EthOss EK Strauss Degranulation Bur Kit, Ethoss Regeneration Ltd, Silsden, UK), followed by rinsing with sterile saline. After completion of the procedure, a severe buccal hard and soft tissue defect was evident (Fig. 5). The patient used an acrylic partial denture as a provisional prosthesis during the whole healing period, without applying any pressure on the surgical site.

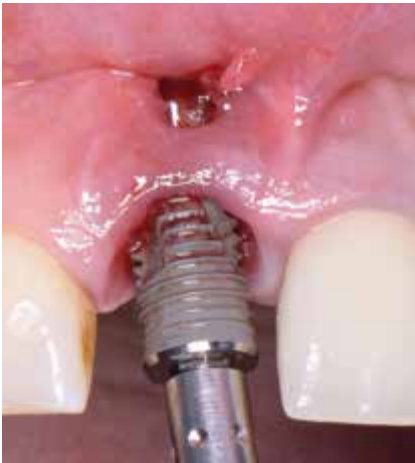
4 | "Atraumatic" removal of the failed implant using the implant driver in an anti-clockwise direction.

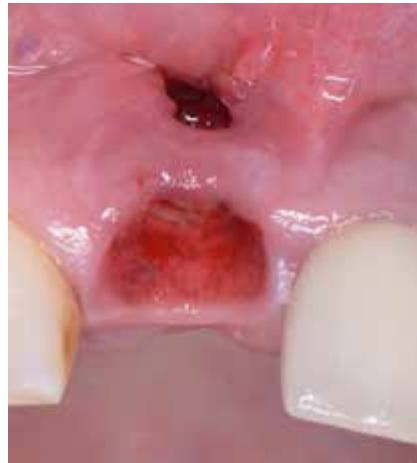
5 | The site immediately after removal of the implant, presenting a severe lack of soft and hard tissues buccally.

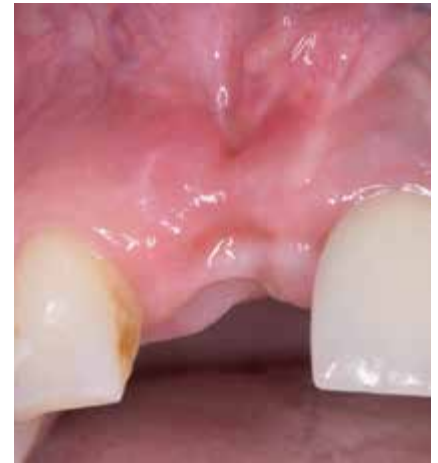
6 | Secondary intention healing for 6 weeks to allow the body to create new soft tissues.

The site was left to heal spontaneously under secondary intention. After 6 weeks, the area was free of any inflammation and uneventfully covered by newly-formed soft tissues (Fig. 6). A new CBCT scan and digital impressions were taken and a digital workflow was carried out by Paltop Digital Solutions using the Implant Studio software (3Shape, Copenhagen, Denmark) in order to identify the ideal size of implant and its precise 3D positioning (Fig. 7). According to the digital plan a surgical guide was 3D printed. Under local anesthesia, a site-specific, papilla-sparing, full-thickness flap was designed, as described by Greenstein and

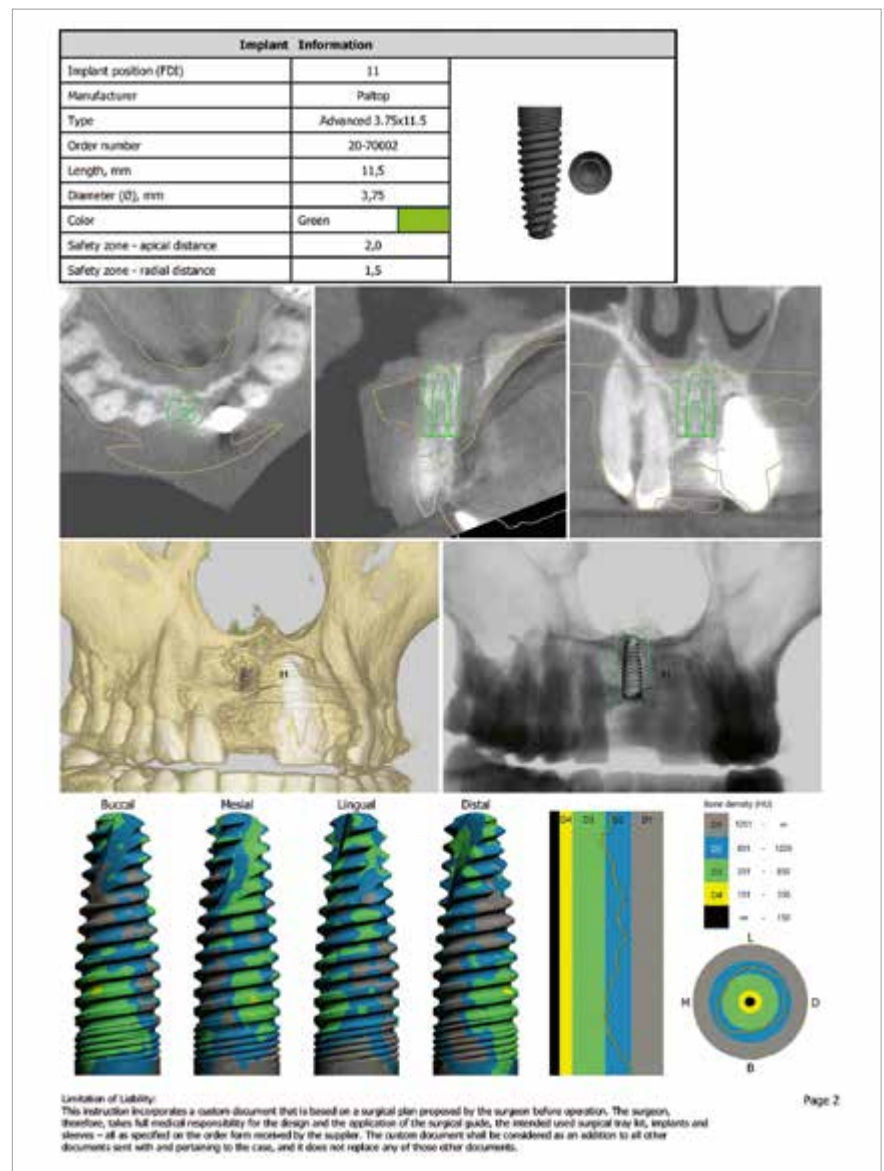
7 | Digital planning of the case. A 3.75X11.5 implant was selected, and the optimal positioning was digitally planned.

In the presented case, virtual dental implant planning allowed not only for a prosthetically driven approach, but also for the selection of the appropriate implant diameter and its precise positioning into the bony envelope, which are fundamental parameters for the successful reconstruction of the missing bone buccally [17, 18]. In this case, the wrong positioning of the failed implant, and its

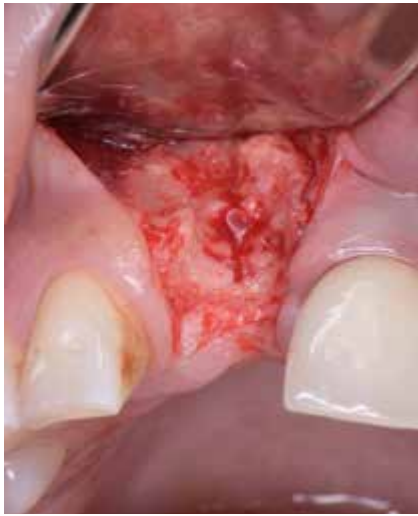
8 | Site specific, papillae sparing flap raised, revealing the bone defect.

Tarnow in 2014 [2] and carefully raised, revealing a large 3-wall bony defect with completely missing buccal plate (Fig. 8). The site was then debrided of all soft tissues; the surgical guide was fitted and all the drilling steps were carried out in a fully-guided manner (Fig. 9). A 3.75 X 11.5 tapered implant (Paltop Advanced Plus, Paltop Dental Solutions Ltd, Israel) was placed in the planned 3D position (Fig. 10). After placing the cover screw, the site was grafted (Fig. 11) utilizing a

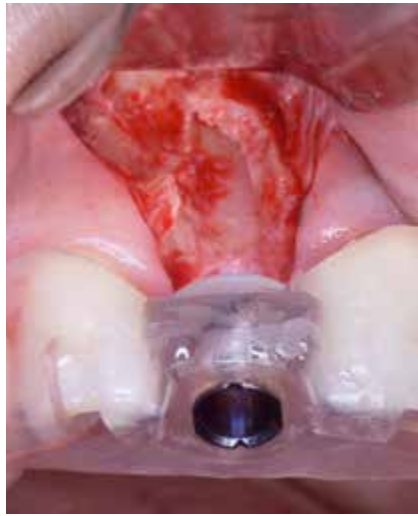
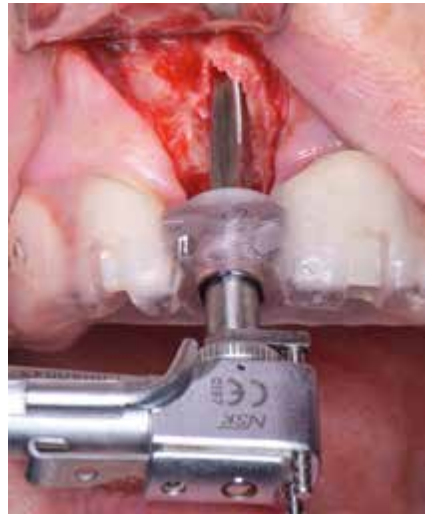
9a & b | The surgical guide fitted on the adjacent teeth and a fully-guided osteotomy was carried out using the dedicated NSK handpiece (Nakanishi Inc., Tokyo, Japan).

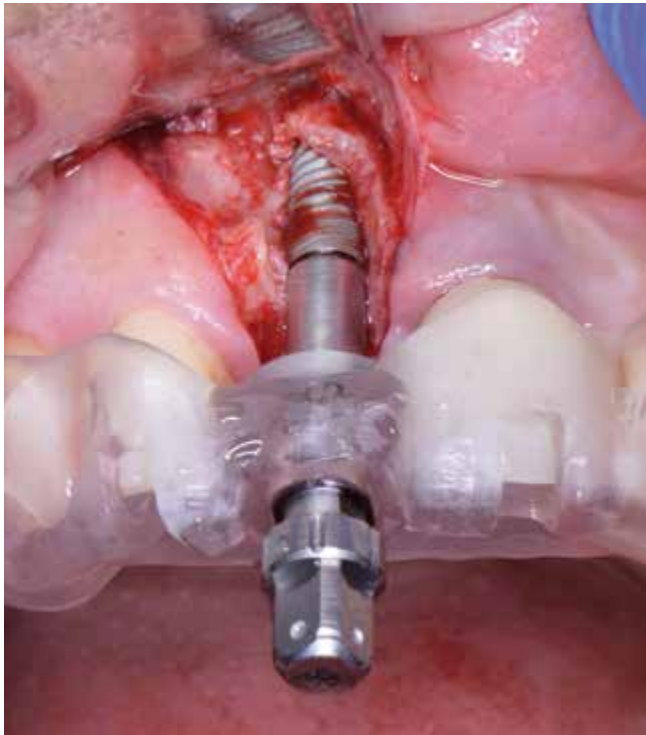
10a & b | Fully-guided accurate 3D placement of the implant

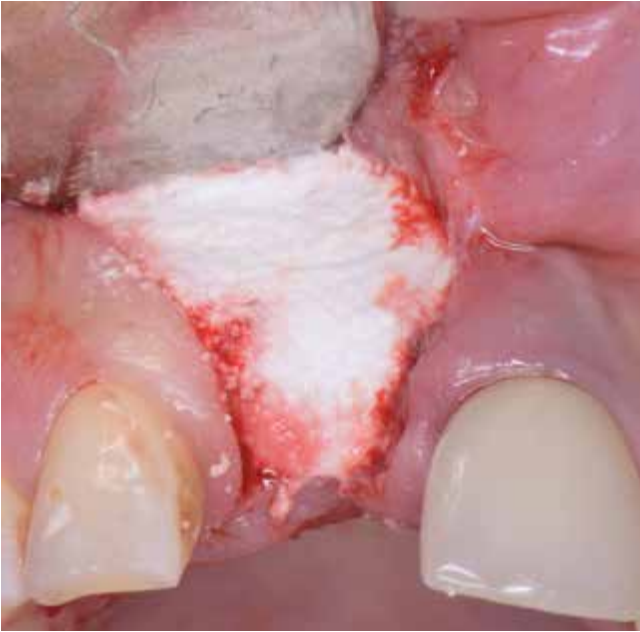
11 | The area was grafted with 0.5cc β -TCP/CS (EthOss). No membranes were used.

self-hardening resorbable synthetic bone grafting material (EthOss, Ethoss Regeneration Ltd, Silsden, UK), consisting of β -TCP (65 %) and CS (35 %), as described by the authors in previous publications [1, 3, 4]. No barrier membranes were used. The flap was repositioned and sutured without tension (Fig. 12) with 5-0 monofilament sutures (SKD Mono, Miromed, Lainate, Italy) and a periapical x-ray was taken (Fig. 13). Antibiotic therapy consisting of 500 mg amoxicil-

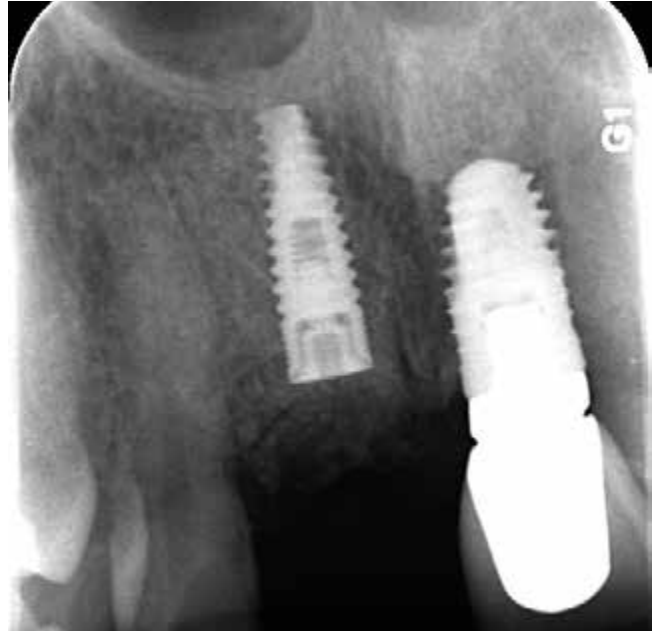
12 | Periapical x-ray immediately post-op.

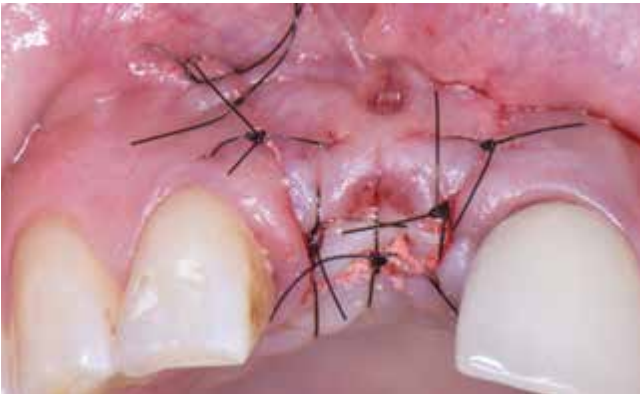
13 | Repositioning of the mucoperiosteal flap and suturing with 5-0 monofilament sutures.

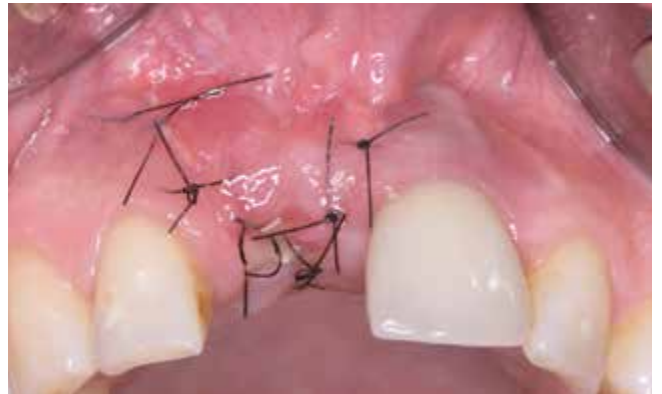
14 | Uneventful healing of the site one week post-op.

lin every 8 hours for 5 days and mouth rinsing with oxygen-releasing mouthwash (bluem, Zwolle, Netherlands) every 8 hours for 10 days were prescribed. The sutures were removed one week post-op (Fig. 14).

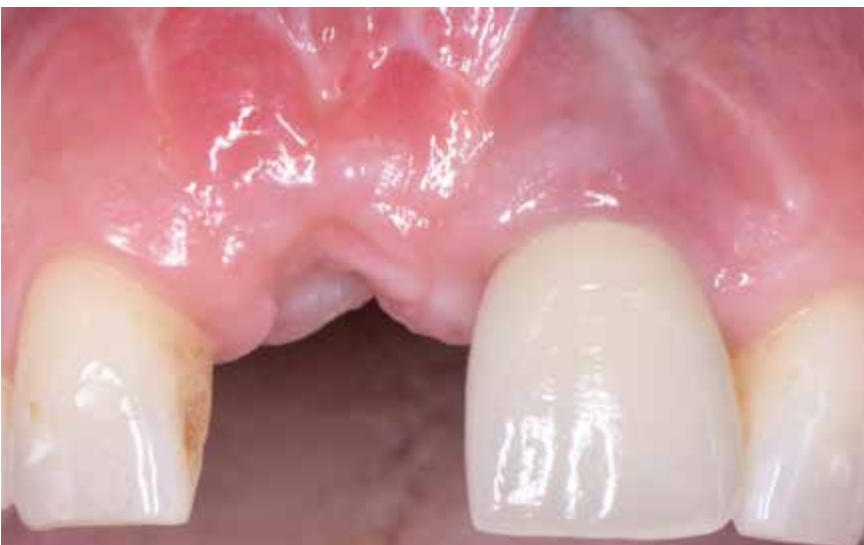
15 | Clinical view 12 weeks post-op. The architecture of the area has been successfully restored. Note the zone of thick keratinised soft tissues that have been regenerated by the host to cover the reconstructed high quality bone around the implant.

After 12 weeks, the healing was uneventful (Fig. 15). A periapical x-ray showed excellent osseointegration of the implant and consolidation of the grafting material (Fig. 16). A linear crestal incision was made to access and remove the cover

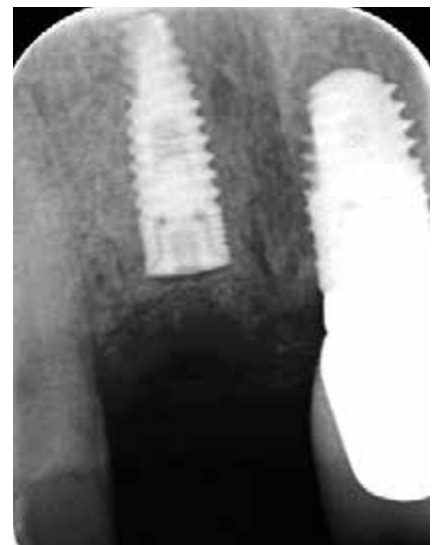
16 | Periapical x-ray 12 weeks post-op.

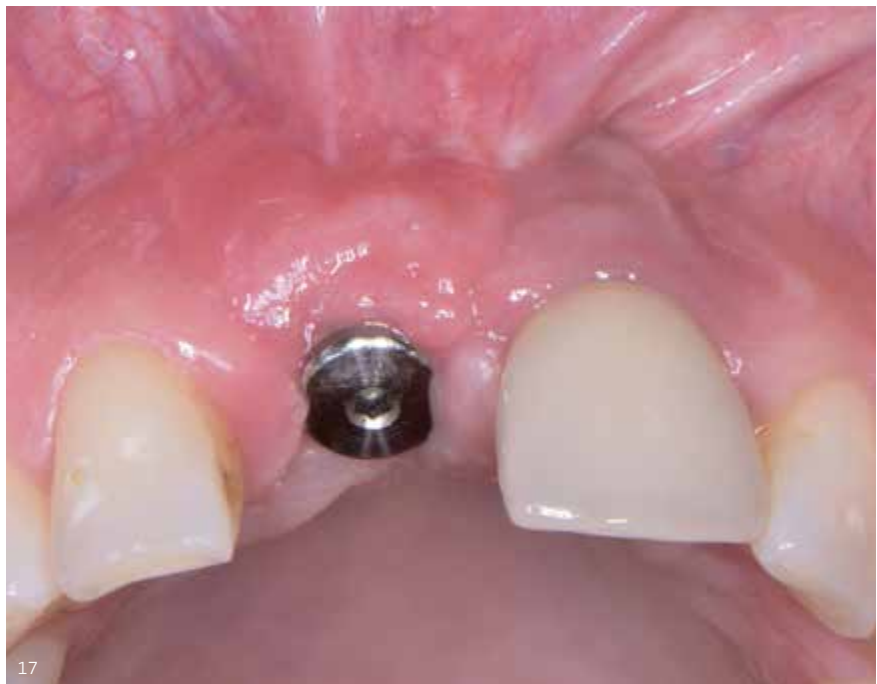
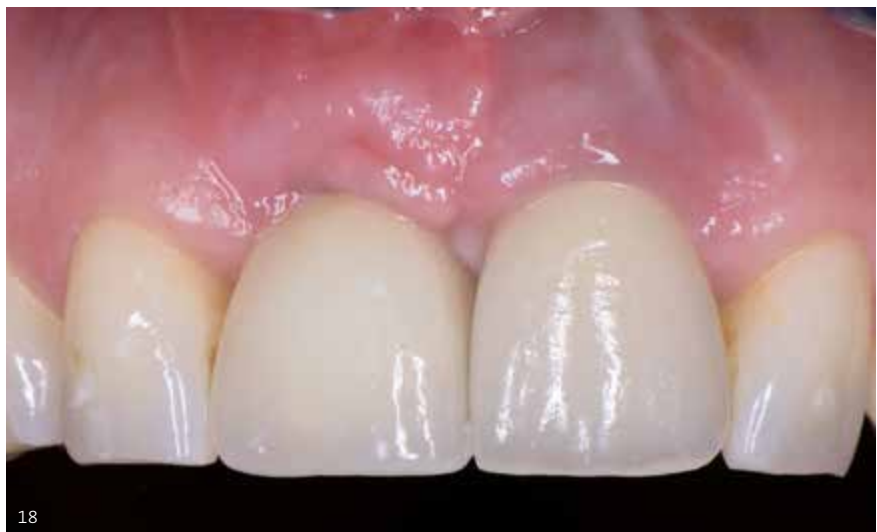
17 | Two weeks after uncovering the implant. 18 | Final result.

screw, and the secondary stability of the implant was measured by resonance frequency analysis (PenguinRFA, Integration Diagnostics Sweden AB, Goteborg, Sweden). An ISQ-value (Implant Stability Quotient) of 75 was recorded, demonstrating high stability. A healing abutment was placed, and after allowing the soft tissues to mature for two weeks (Fig. 17), an open-tray impression was taken and the final screw-retained crown was fitted resulting to a successful outcome, regarding esthetics and function (Figs. 18 and 19).

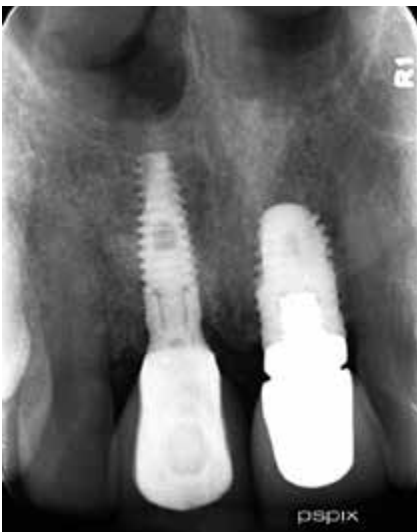
19 | Periapical x-ray after fitting the screw-retained implant crown. The grafting material is turning over, being replaced by the regenerated bone.

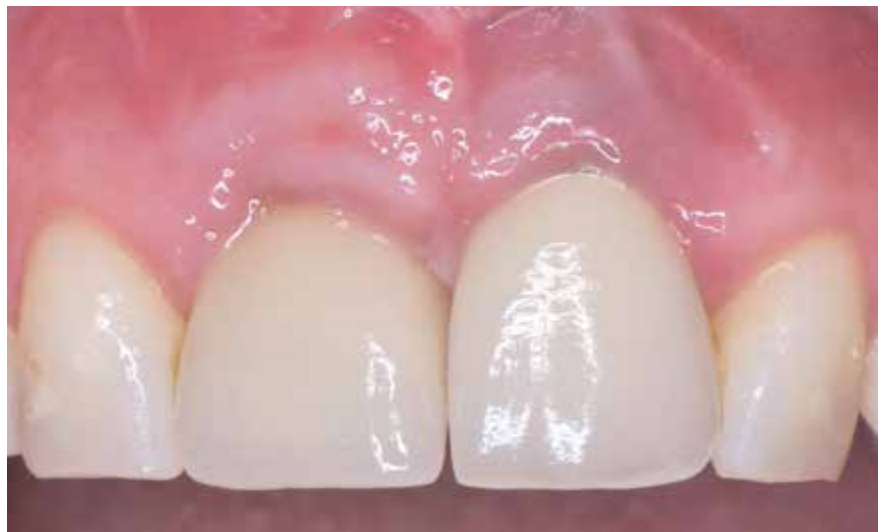
20 | Clinical view one year post-op revealing a stable outcome and further maturation and adaptation of the soft tissues.

At follow-up one year post-operative, the architecture and the volume of the site had been successfully restored and the ridge buccally was covered by thick regenerated keratinized soft tissues (Fig. 20). A CBCT at this point showed that the buccal bone was successfully regenerated (Fig. 21).

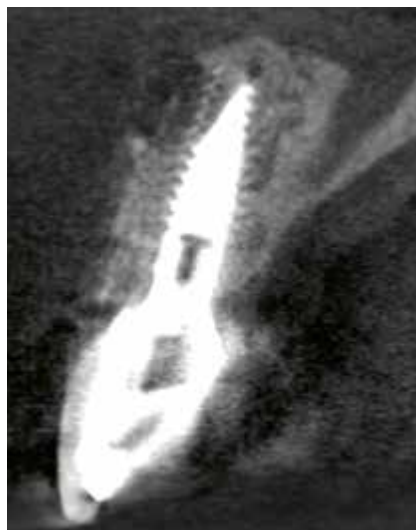
21a & b | CBCT one year post-op showing the regeneration of the buccal bone.
