Photo Report by DMNC Roofing

Nov 3, 2020 | 9 Photos

Inspection Report

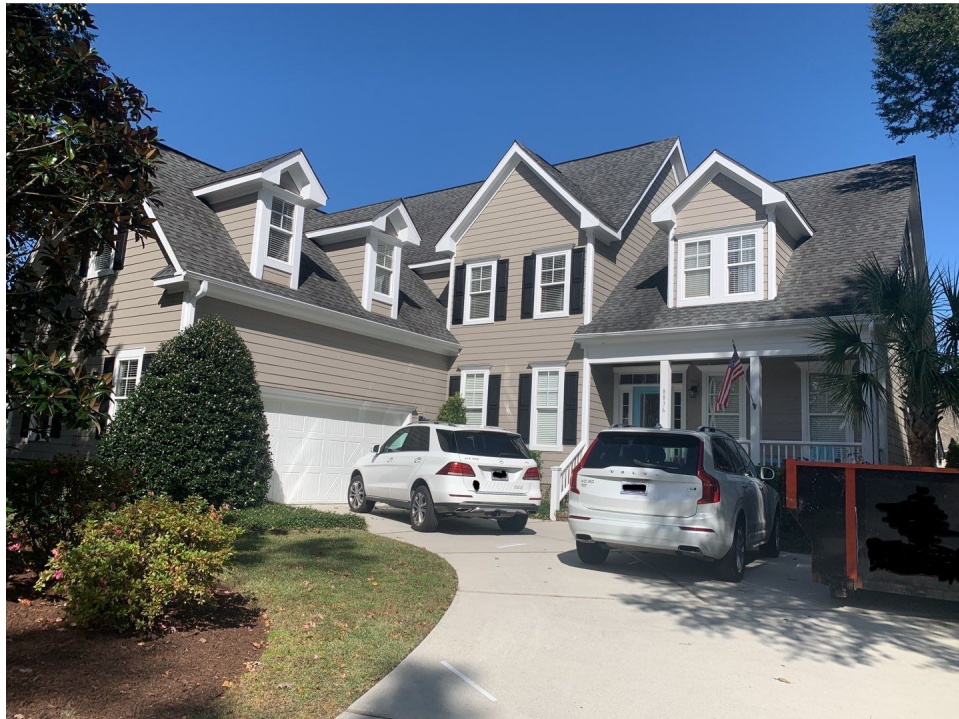
In general the roof covering appears to be in good shape considering it's age, and no major storm damage was found. The individual shingles seem to seal well. However, significant granular loss was observed indicating aging and drying of the shingle core. This is to expect over time and more so in this hot ocean climate. An additional life span of 7 to 10 years can be expected. This estimate is solely based on the shingles normal wear and tear and does not include future potential storm damage that also may become more possible as the shingle ages.
