RODRELO LLC.
Consulting and Representation

Failure Analysis Report

Report Number: 1-RR-618

- Well: 1-1-1
- Operator: Operador 1
- Date of failure: 11/2/2020
- Artificial Lift type: SUCKER ROD PUMPING
- Type of failure: SUCKER ROD PART
- Failure description: ¾" Norris 97 Guided 4x
- Depth of failure: 4400'

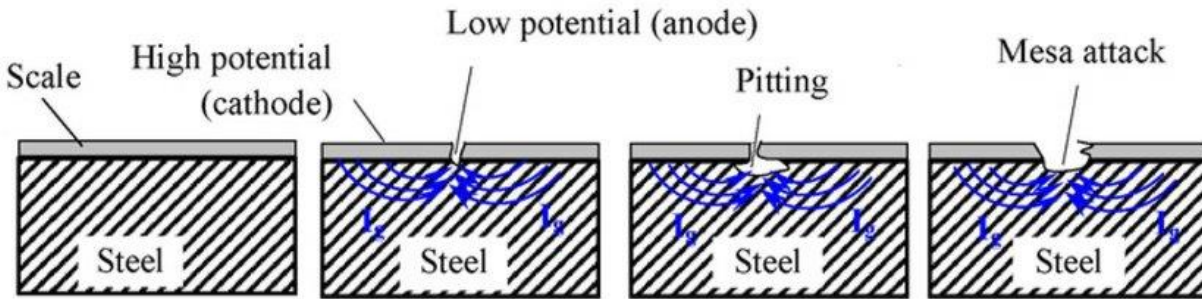
Under Deposit Corrosion

Above is the typical localize corrosion process associated to under deposit corrosion. This phenomenon varies depending on what type of deposit and what type of corrosive agent is present.

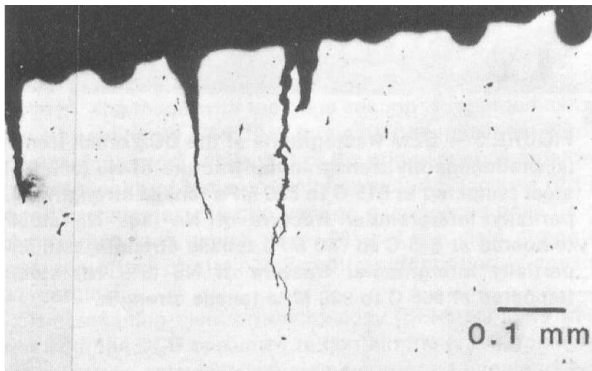
Typical H₂S sharp pit morphology

H₂S pitting morphology normally takes the shape of sharp edges, and it is hard sometimes to determine if they are pits or cracks. The embrittlement that happens on the tip of the crack, the highest loading section of the crack facilitates the entering of atomic Hydrogen that fragilize the surrounding area of steel making the propagation fasters on every loading cycle.
