TEST PROCEDURE & READING RESULTS

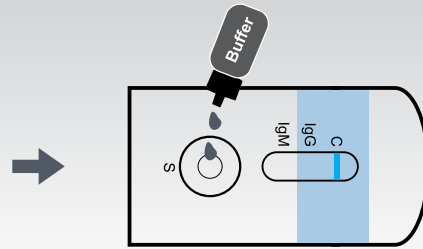
1 DROP OF BLOOD

➔ 2 DROPS OF BUFFER

➔ WAIT 15 MINUTES

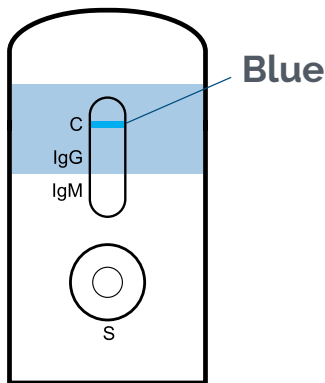
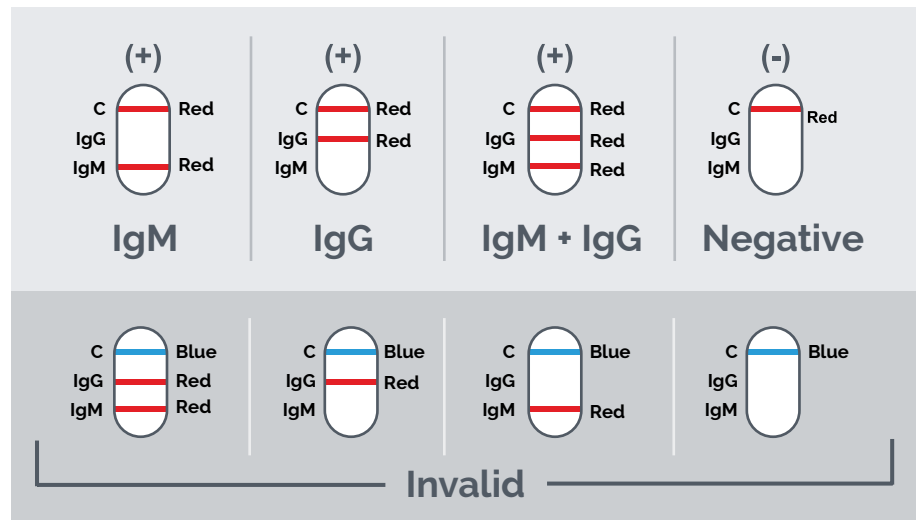
READ RESULTS

NEGATIVE

The coloured line in the control line region (C) changes from blue to red. No line appears in the test line regions M or G.

IGM POSITIVE

The coloured line in the control line region (C) changes from blue to red, and a coloured line appears in test line region M.

IGG POSITIVE

The coloured line in the control line region (C) changes from blue to red, and a coloured line appears in test line region G.

IGG AND IGM POSITIVE

The coloured line in the control line region (C) changes from blue to red, and two coloured lines appear in test line regions M and G.

INVALID

Control line is still completely or partially blue, and fails to completely change from blue to red. Insufficient specimen volume or incorrect procedural techniques are the most likely reasons for control line failure. Review the procedure and repeat the test with a new cassette. If the problem persists, discontinue using the kit immediately and contact your distributor.
